Great North of Scotland Railway Signal Boxes

Keith Fenwick and Graham Maxtone

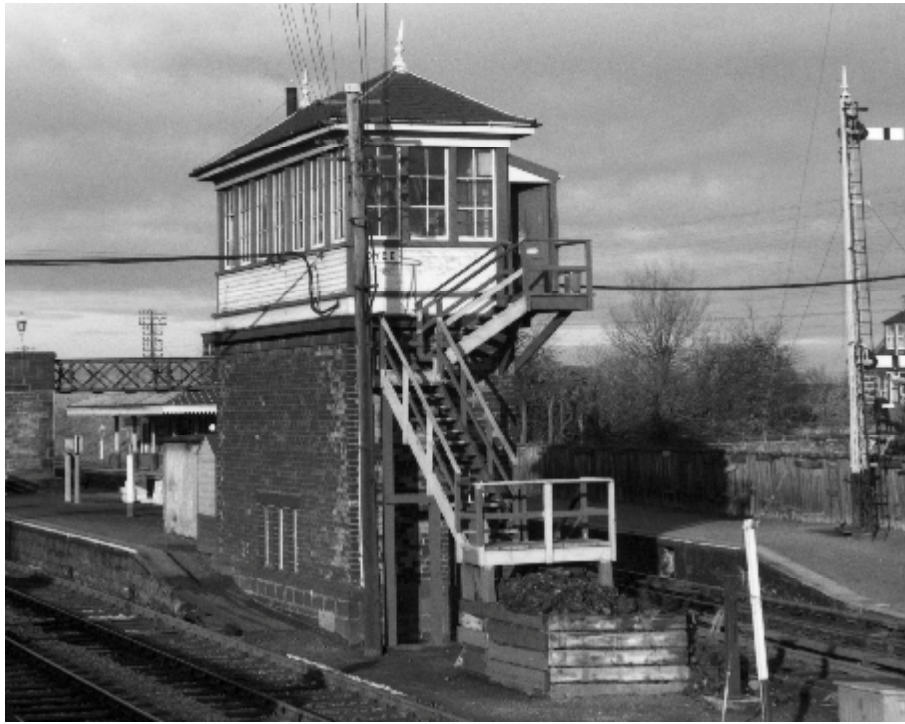
Dyce South (Junction) is an example of one of the larger Type 1 boxes, having a low stone base and vertical boarding. The box once controlled the junction for the Buchan lines (running behind the structure) and is still in operational use although the lever frame has been replaced by a standard NX panel to control the new colour light signalling in the area (Douglas Hume)

Type 1 was the earliest design of Great North box and is illustrated by Kittybrewster South in *The Signal Box*. It had a substantial brick or granite base up to cabin floor level supporting a wooden superstructure - with either vertical or horizontal boarding. It is not known if the both arrangements of boarding are original or if one form is the result of rebuilding. The sides were fully glazed with six-pane windows in a two by three arrangement (some had nine panes arranged three by three) and the roof was hipped with overhanging eaves. While the two Kittybrewster cabins and that at Dyce were very high, all the others were of normal height. Dyce is the only example still in use.

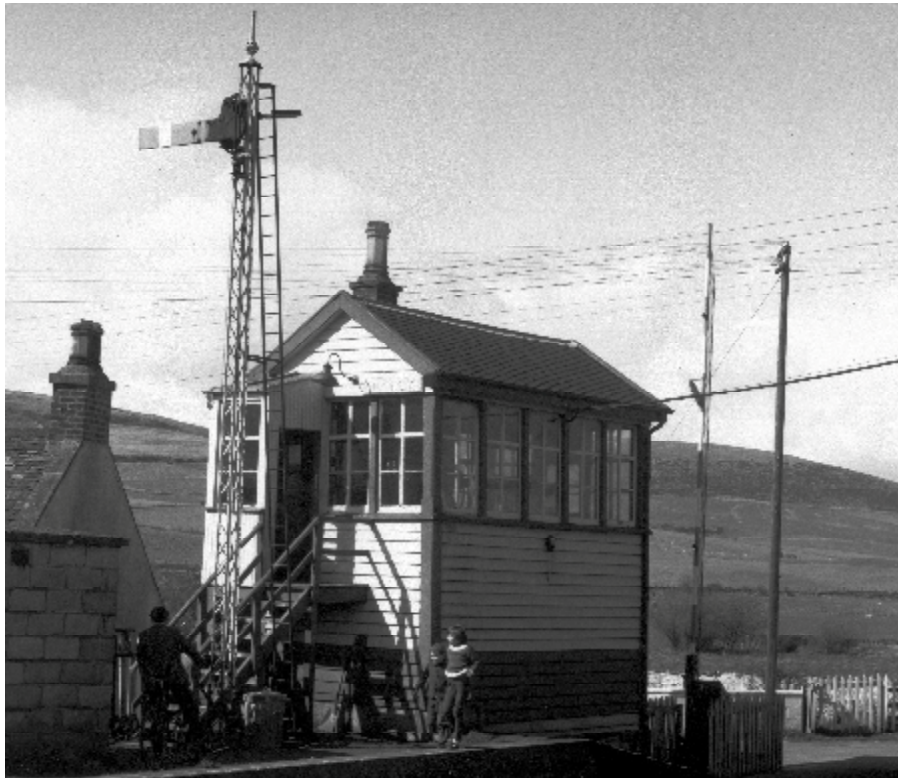
Gartly (North) is an example of a Type 2a 'box and also controlled the adjacent level crossing as well as breaking the section between Kennethmont and Huntly. Following singling of the main line in the late 60s the 'box survived a further 3 years as a gate box until the crossing was automated in May 1973. (Graham Maxtone)

As noted above, type 2 was a gable-roofed box of quite simple design. This type is subdivided based on the design of the roof. Type 2a, which is illustrated in *The Signal Box* by a drawing of Urquhart and by a photo of Elgin West (later Elgin Centre, and still standing although not used for signalling) was of wood construction from ground level, with four solid timber corner posts, horizontal boarding and six-pane windows in a 2 by 3 arrangement. There was full glazing on each end and a small but noticeable overhang on both the front and the sides. A brick chimney was provided. This design was first used in 1884 on the Coast line, which was interlocked from its opening, and examples continued to be built until 1888. In addition two late examples, Banff of 1900 and Spey Bay of 1912, are recorded. The design of Spey Bay fits in nicely with the original box of 1886, so it is likely that the so-called new box of 1912 was in fact the original box. The date for Banff is based on the introduction of interlocked signalling - one of several places about which the Board of Trade complained continuously.

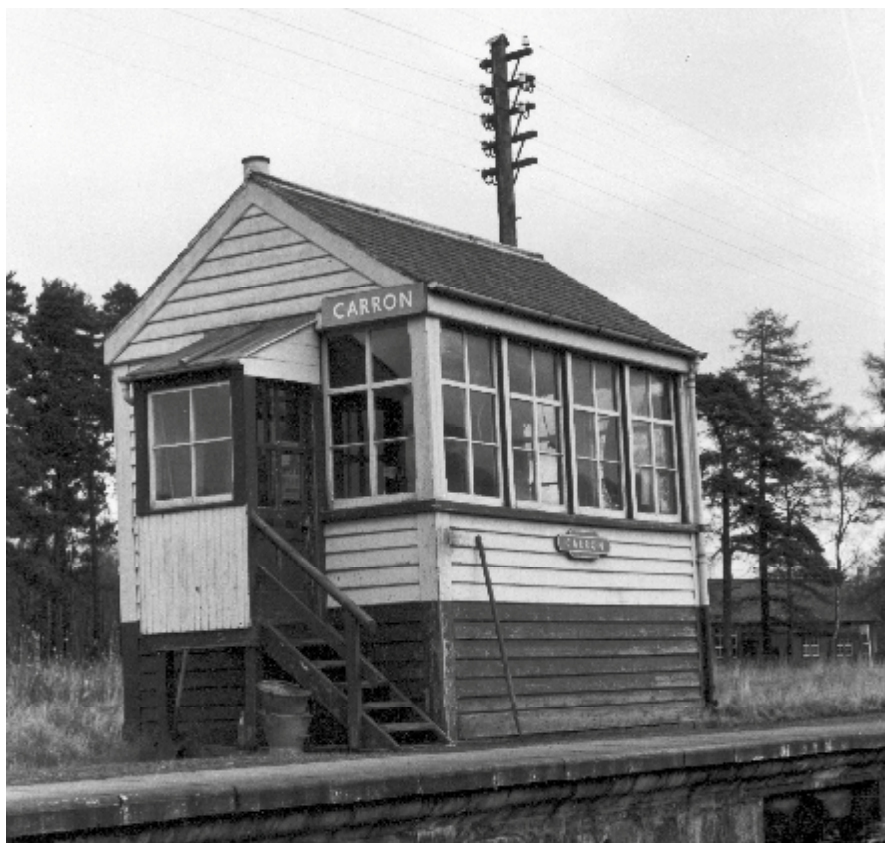
Carron is a Type 2b box, seen here in 1968 just after closure although a shunting pole still leans against the front wall. Note no overhang on the roof when compared to the previous photo of the Type 2a at Gartly. Porches were later additions to all GNoS 'boxes' (Forbes Alexander)

Type 2b was very similar, again of timber construction, with the principal difference being that the roof finished almost flush with the sides. Most had windows on two-thirds of the ends only, although there are examples with completely glazed ends where the extra visibility was needed. This was the commonest design and can still in operational use at Huntly South although refurbishment has resulted in the loss of its original style. Several had toilets added at the top of the steps in later days. This design was installed between 1888 and 1901 at locations throughout the system, with a further example at Aberlour in 1910 (another transplant?).

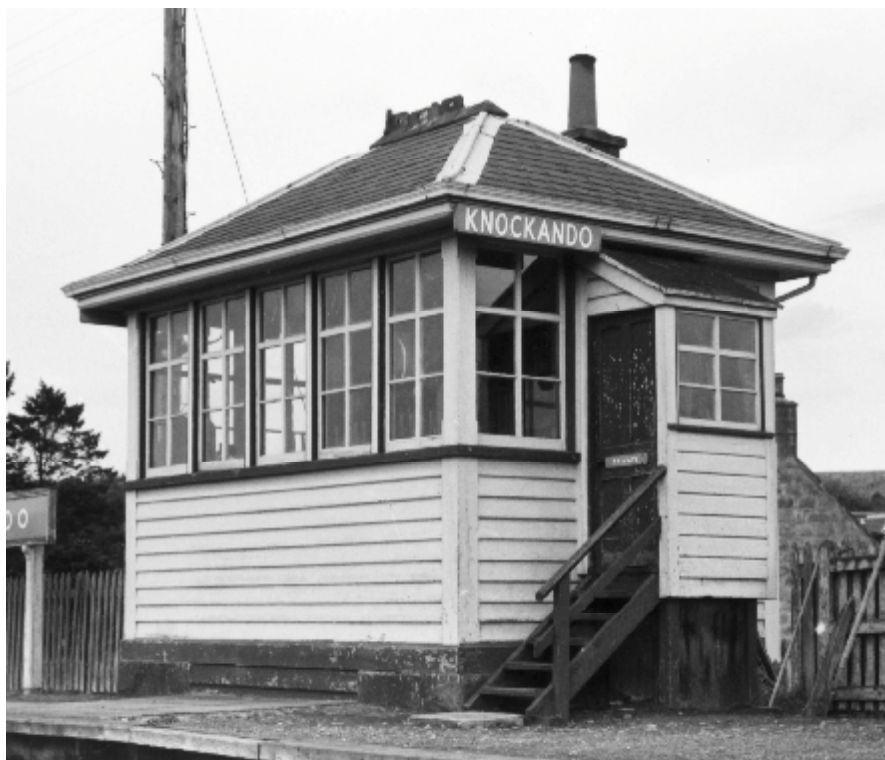
Type 3a is well illustrated by this view of **Knockando**, on the Speyside line. The box dates from the opening of the station in 1899, as part of the expansion of facilities to handle the whisky traffic. It was known as Dalbeallie until 1905. The photo was taken in November 1968, just after final closure of the line, by which time the terra-cotta finials had been damaged. (Forbes Alexander)

Type 3a was in many ways a hipped-roof version of type 2a. Of all wood construction, it had horizontal boarding, with 6 pane windows which only covered part of the ends and again a sizeable overhang to the roof. Terracotta finials and ridge tiles made this an attractive design. The only surviving example is at Knockando, where it is preserved as part of the Tamdhu Distillery visitor centre.

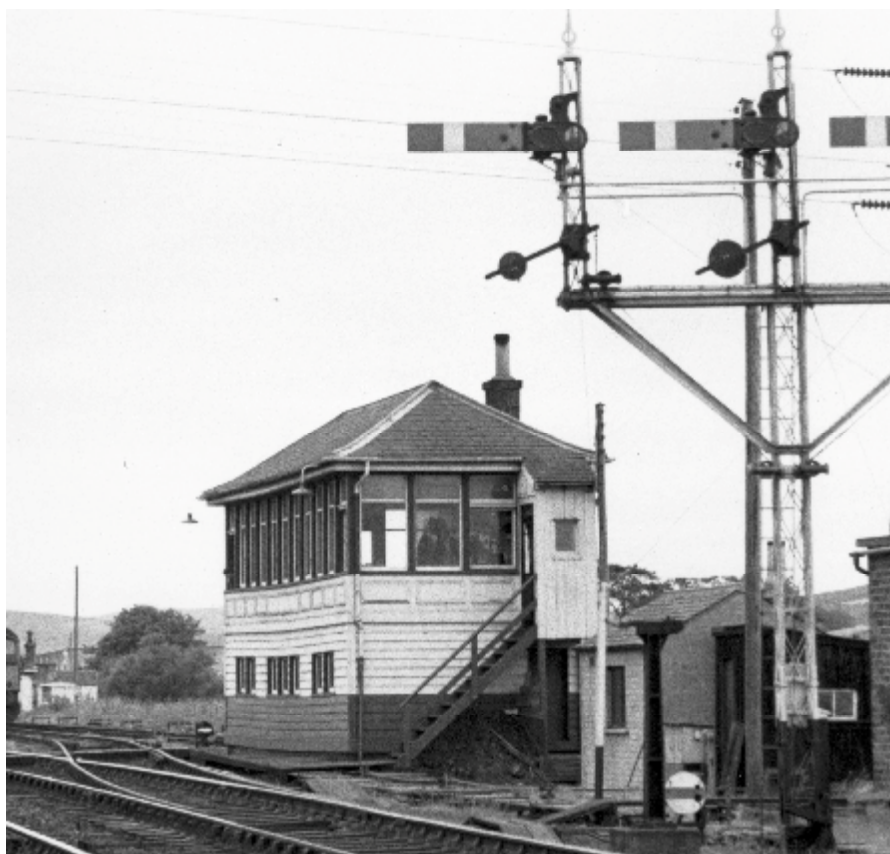
Keith Junction is a Type 3b box and still survives today. Having been refurbished since the photo was taken it still retains most of its original character although it still sags in the middle. The only other 3b example still in operational use is at Inverurie. (N. Forrest/GNSRA)

Type 3b was a development of 3a, again wooden, with horizontal boarding, but the addition of some larger horizontal panels to give relief to an otherwise plain design. The roof had a large overhang and the windows 3 panes. Four examples are known, of which those at Inverurie (illustrated in *The Signal Box*) and Keith are still in service. Despite refurbishment both survivors are still sagging badly in the middle.

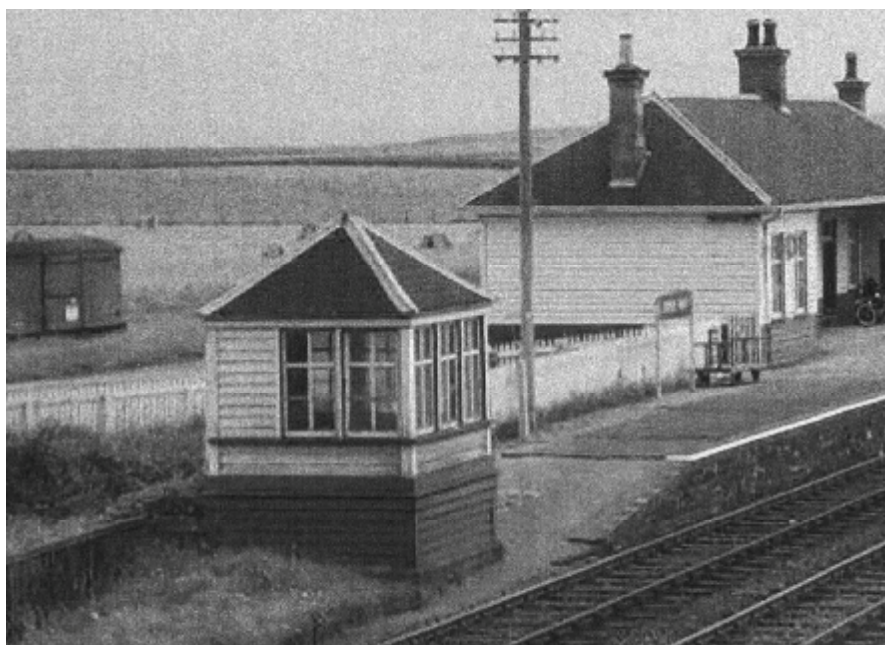
Four examples are known of this delightful design of minor box, seen here at **Spey Bay** in the mid 1960s. A four-sided roof and horizontal weatherboarding characterise the design. All four examples of this design were on the Coast Line from Portsoy to Elgin, which was opened between 1884 and 1886 and therefore signalled at that time. This particular structure was moved to a garden at Clochan near Buckie just before the Coast line closed. It now resides in the yard at Dufftown (KDRA) in poor condition. (M. Stephen)

Another design which recurred, albeit at only three known locations, was that used for the minor boxes at Spey Bay, Buckie and Tochieneal. This was a small, square, four-sided roof box. Construction was stone to floor and then horizontal weather-boarding. The existence of the box at Tochieneal only recently came to light, and that at Buckie only appears in early George Washington Wilson photographs, but it is quite possible that this design was installed on the Coast line at other stations where two boxes were provided, such as Portknockie and Calcots. Subsequent photographic evidence confirms Portknockie was of this style. The minor box at Spey Bay (found in a garden at Clochan near Buckie) is currently at the KDRA yard in Dufftown but in very poor condition and unlikely to be used.

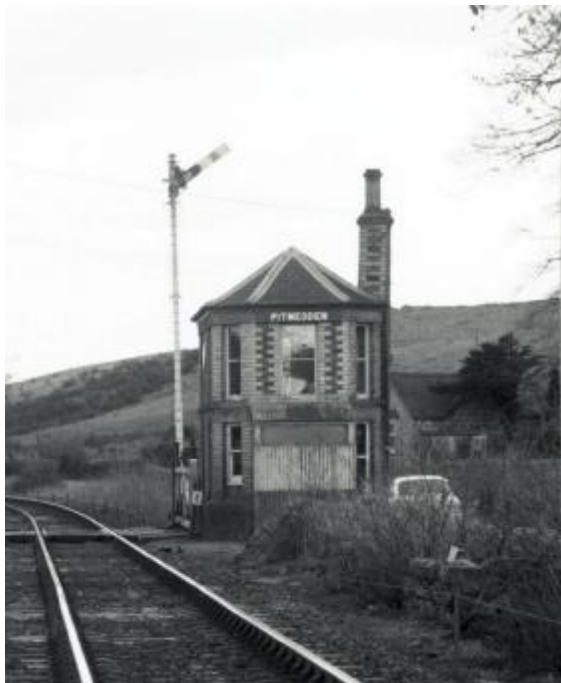
Pitmedden, on the main line between Dyce and Inverurie guarded a level crossing at which a station was erected principally for the local laird. Tickets were available through the door under the lean-to. The only other buildings at the station were two open-fronted platform shelters. The installation of user operated barriers resulted in closure on the 11th of November 1973. (Graham Maxtone)

A really strange affair was the box at Pitmedden, which guarded the level crossing gates there. This was of brick with eight sides and a form of hipped roof to match. Although there were windows on each side, only about half the total frontage was glazed. A booking office was included in the building, which must be a very early one, possibly because there were no other buildings at the station to accommodate the crossing keeper while on duty. The granite foundations still exist. There was another odd box of great antiquity at the north end of Maud which had some similarities to Pitmedden. It can be seen in the distance in a photograph taken in GNSR days and appears to have a fully glazed, wooden superstructure on a stone base. The base survives - with six sides!

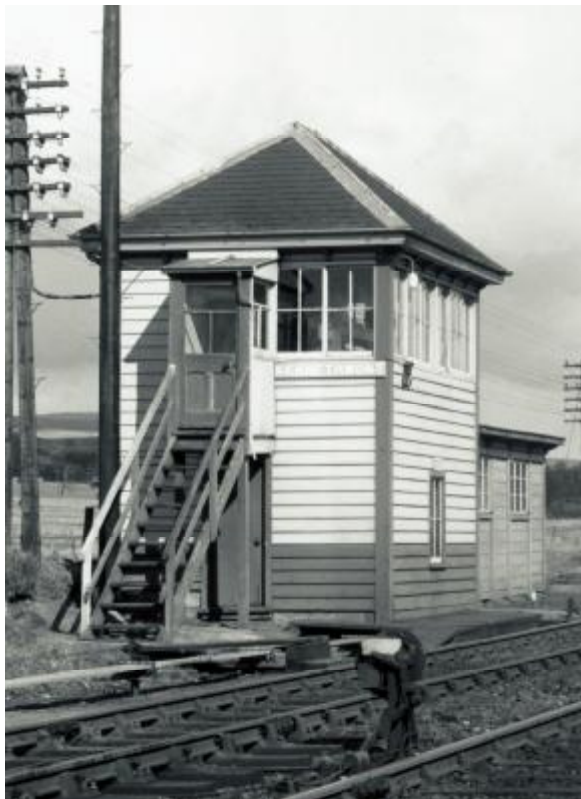
Kennethmont (North) is a Railway Signalling Company design. A similar structure was provided at Kennethmont South which was likely moved to Craigellachie where it was installed on the branch platform. Refurbishment in the early 2000's resulted in an extension to the 'box although the basic RSC design is still recognisable. (Graham Maxtone)

There were three locations with Railway Signalling Company hipped roof boxes. Two boxes were installed at Kennethmont, the South box later being moved to Craigellachie, where it was installed on the branch platform and is therefore referred to as Craigellachie Strathspey.

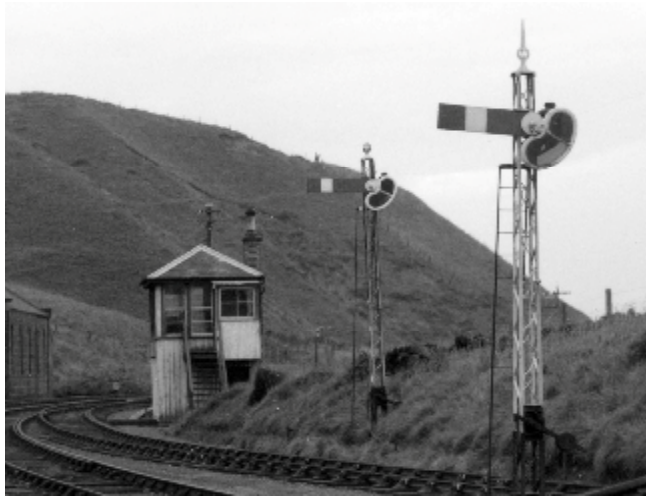
Macduff was of all wooden construction with vertical boards and a hipped roof. The windows consisted of four panes with no vertical divider and there was a small overhang to the roof. Lower quadrant signalling survived here until final closure in August 1961. (Douglas Hume)

Macduff had a wooden box with vertical boards and hipped roof. The windows consisted of four panes with no vertical divider and there was a small overhang to the roof. Lossiemouth was similar to 3a but had stone up to the window level at the front and to the roof level at the rear. There were no ridge tiles.

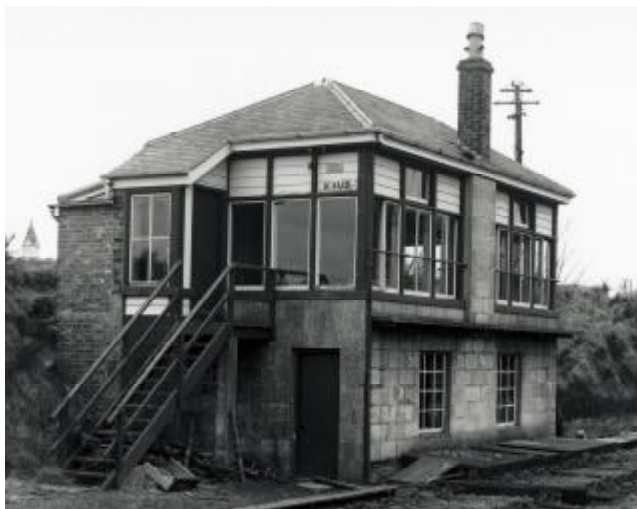
Maud Junction was commissioned in July 1935 during the LNER period and was a North British Type 8 design. It replaced the North and South signal boxes. It was the last surviving signal box on the Buchan section when it closed on the 5th of March 1969. (Graham Maxtone)

The LNER spent very little on the infrastructure of the ex-GNSR lines. Some signals were renewed as upper quadrants, but the only new signal box was that at Maud, to a North British type 8 design!

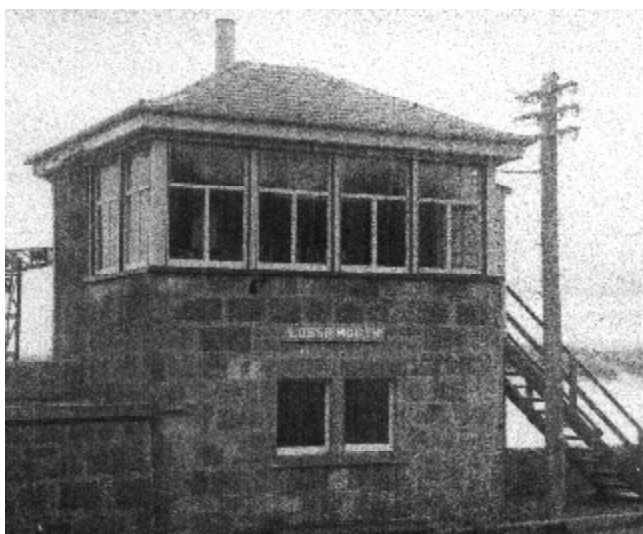
Lossiemouth was similar to a Type 3a but had stone up to window level at the front and to roof level at the rear. As can be seen there were no ridge tiles. (N. Forrest)
